# THE BUILDING SEQUENCE AT HOMWOOD'S LOT, ANNE ARUNDEL COUNTY, MARYLAND

Lauren Franz and Al Luckenbach

## Abstract

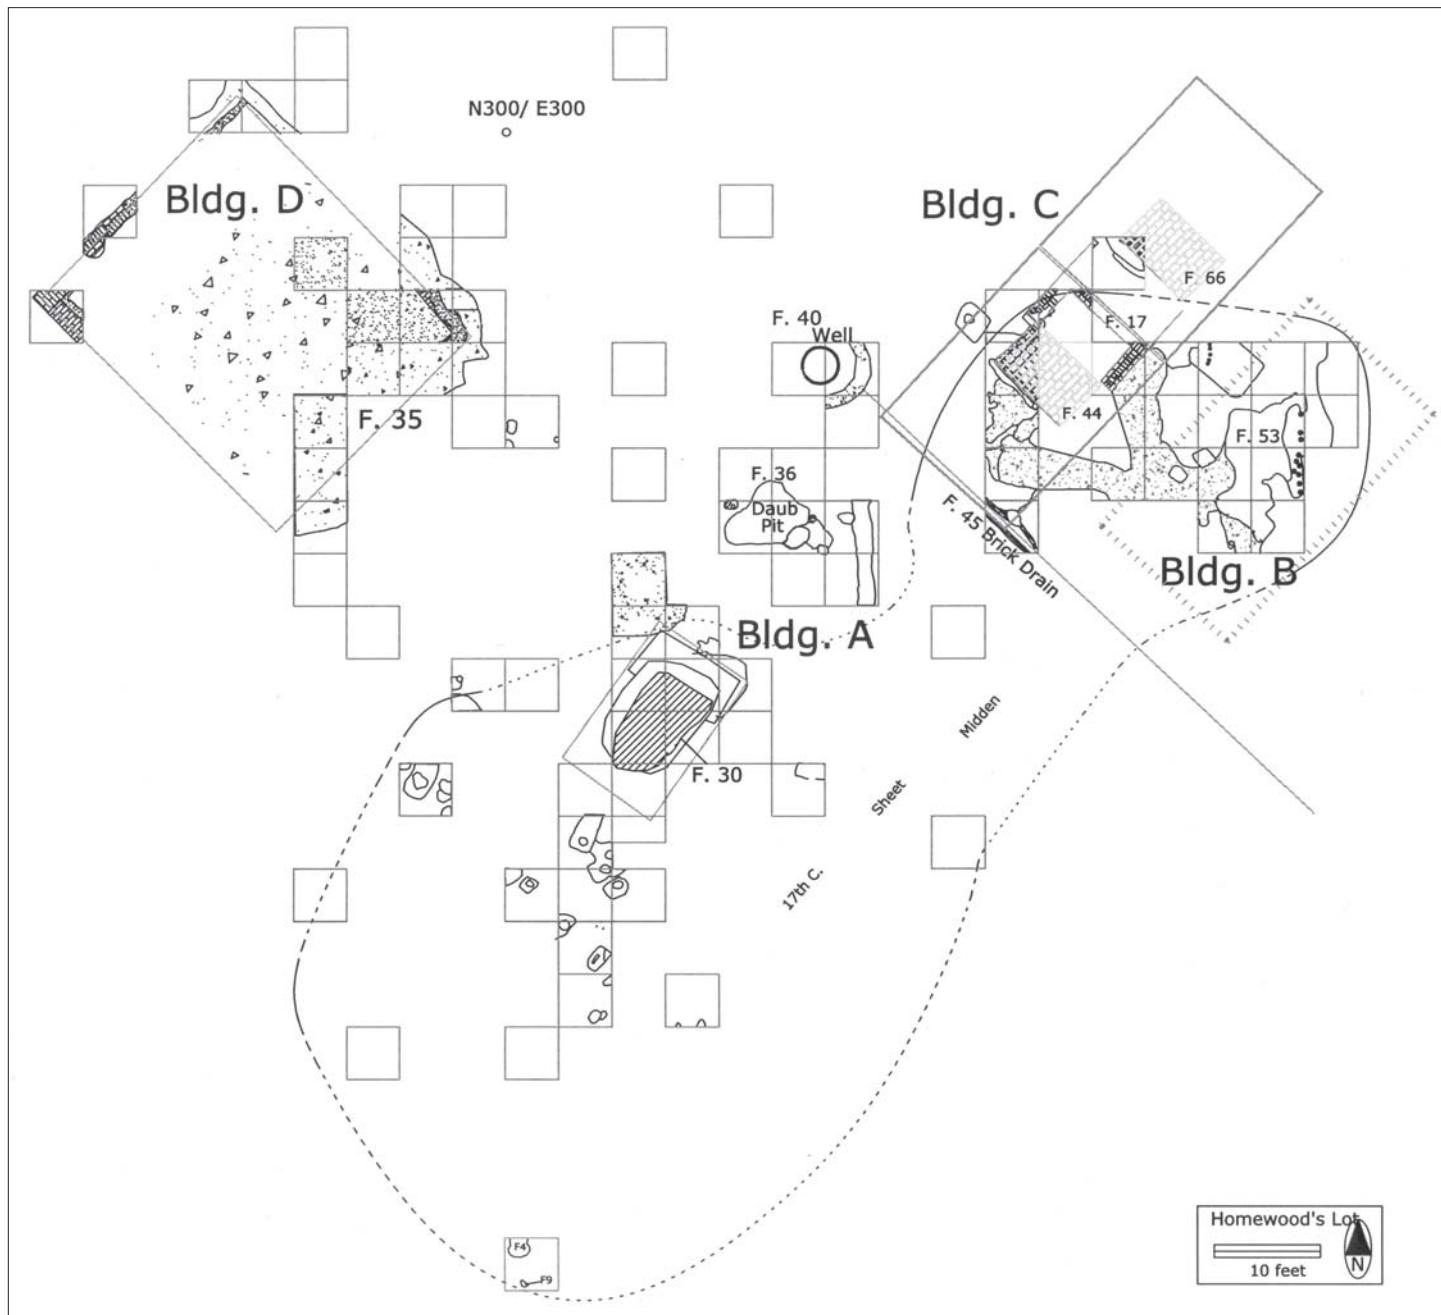
FIGURE 3. Site map of units and features at Homewood's Lot.

determining the location and nature of a series of structures built on the site, and on the earliest components related to the mid-17<sup>th</sup> century Providence settlement (Figure 3).

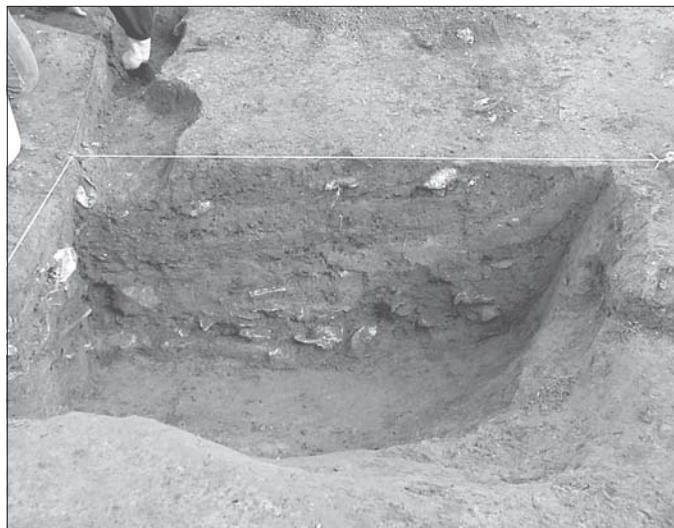
FIGURE 4. Building A cellar (Feature 30).

The nearly full-cellар measured 10 by 6 feet and its base was reached at 2.2 feet below the current ground surface (Figure 4). A summation of the artifacts that were found in this cellar is displayed in Table 1. These included an interesting delftware assemblage, Rhenish stoneware, and small amounts of North Devon and Staffordshire wares. Significantly, there was no English brown stoneware (or white salt-glazed stoneware) found in this feature, suggesting a pre-1680 fill date. Pipe bowl forms suggest an even earlier mid- to late 1660s' deposit.

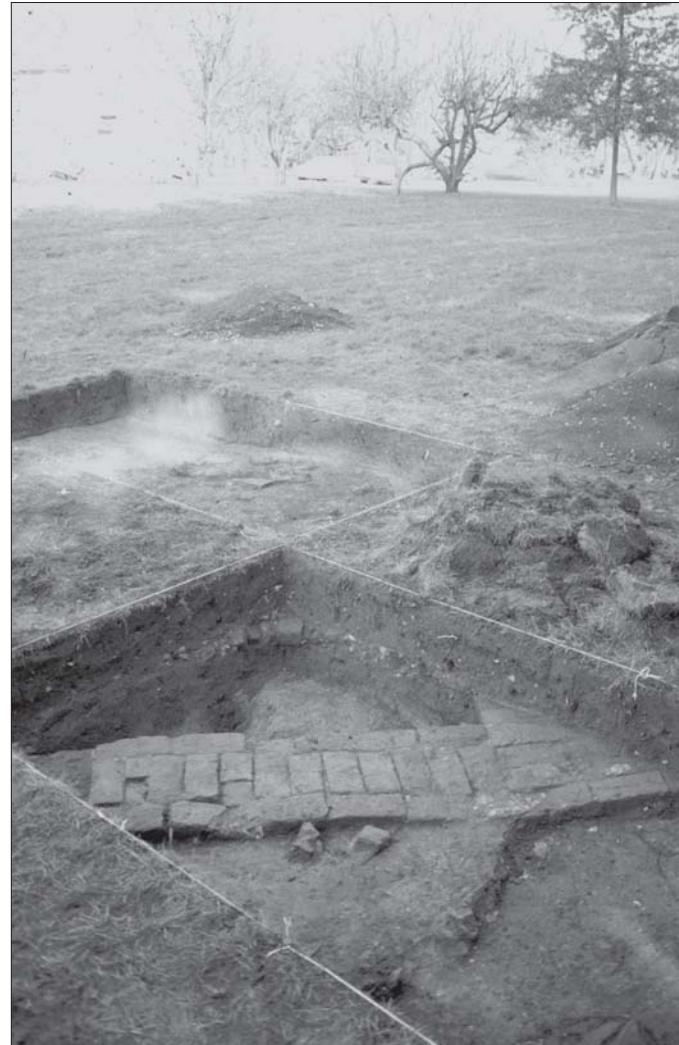
FIGURE 5. H-shaped chimney base (Feature 17).

Perhaps the most intriguing structure at Homewood’s Lot was Building C. This structure was evidenced by an H-shaped brick chimney base (Figure 5) with two associated brick-lined storage pits (Features 44 and 66). A brick drain (Feature 45) once ran through the western end of this building that ultimately attached to a well, which acted as its water source. The brick drain was about half of a foot deep with a chunky brick and pebble layer (Figure 6). The drain extended from the well, through Building C, and continued on at least 20 feet outside to the southeast of the structure.

The kitchen/wash house was located in the northeast corner of the site. The building was likely of earthfast construction, but the lack of identified postholes makes speculation over the size of the building difficult. The H-shaped chimney found inside the building is a 10 by 10-

foot square oriented 45 degrees northeast of grid north. The brick-lined drain is ten feet south of the hearth, while the well is fifteen feet to the west. The distance from the drain to the middle of the chimney is twenty feet. Since only one 5 by 5-foot unit was excavated on the north side of the chimney (to identify the second storage pit and the end of the chimney), a total building length cannot be determined. However, to encompass the drain and both storage pits, the building can be assumed to have been at least thirty, perhaps forty, feet long.

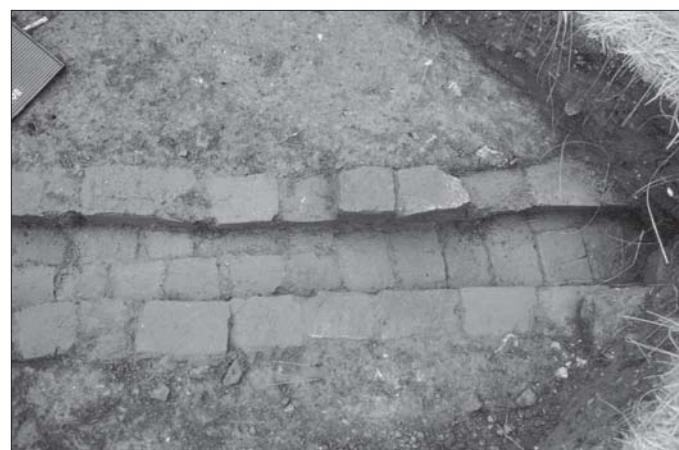
FIGURE 6. Brick drain (Feature 45).

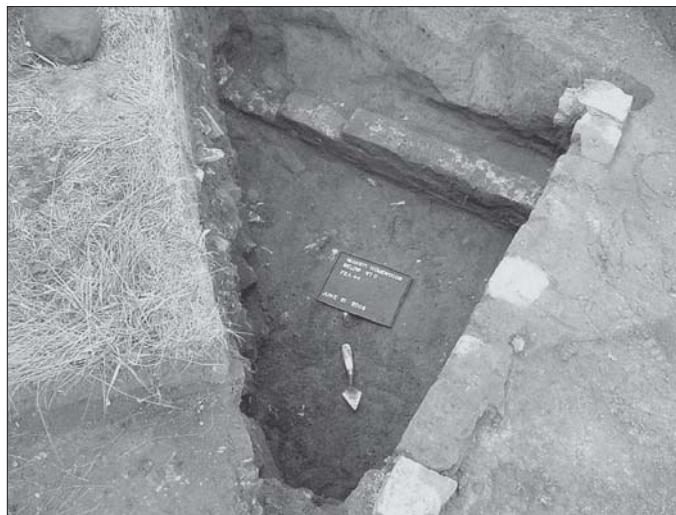
FIGURE 7. Storage pit (Feature 44) to the south of the H-shaped chimney base.

The storage pits associated with this building were to the north and south of the hearth (Figure 7). The pit to the south was the only one tested. This 8 by 6-foot storage pit (Feature 44) was brick-lined. The feature was excavated to the pit floor, which was 4.5 feet below ground surface at the west wall. The brick had been removed from the north and south walls. Evidence of this was the robber's trench, a 4 by 8-foot trench that was about three and a half feet deep, against the south wall of the pit. The bricks used to initially build this cellar were likely re-used from another structure.

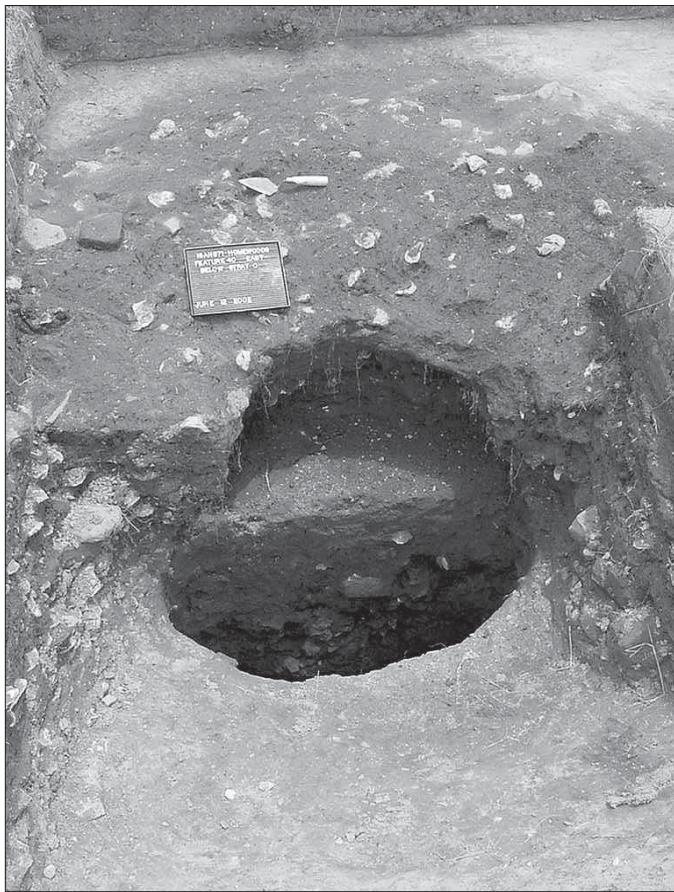
FIGURE 8. The well (Feature 40).

The well itself is located fifteen feet west of the kitchen/wash house (Figure 8). Four five by five-foot units were opened over this feature. Initially a circular dark feature that was ten feet in diameter was delineated; it was later discovered that the feature covered a well about four feet in diameter. When excavation of the feature began, a layer with chopped-up oyster shell and brick was found. Under this layer was a hollow hole that reached down into the feature almost three feet. Excavation continued to a depth of 7.5 feet. The bricks, shaped to fit the circumference of the well, were robbed out down to about 5 feet. This helps to explain why the footprint of the well was so much larger on the surface. Concern for worker safety stopped the excavation of the well before the bottom of the well had been reached.

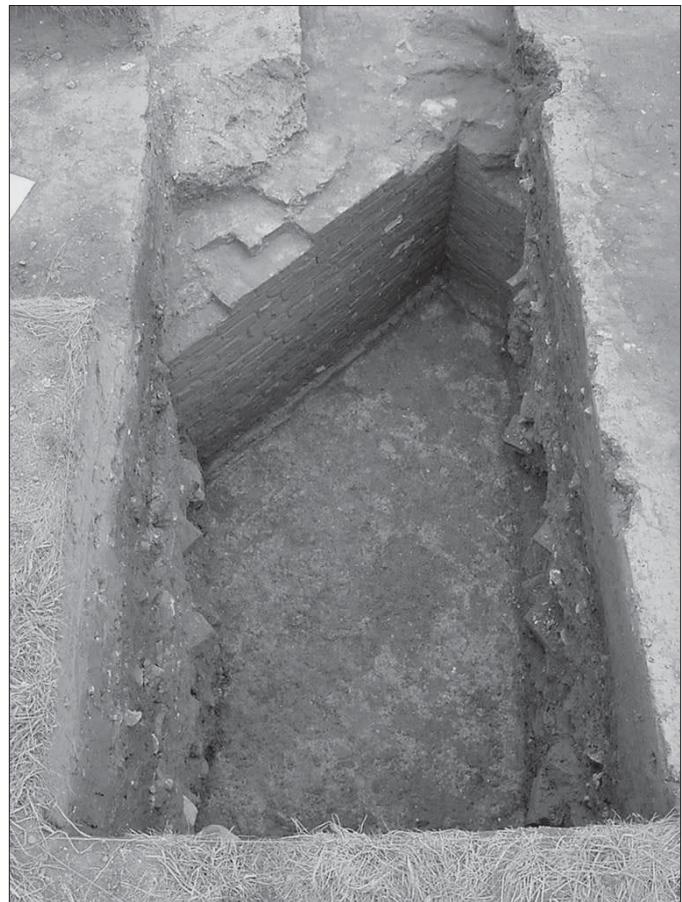
FIGURE 9. Cellar (Feature 35) from Building D, 18<sup>th</sup> century main house .

Only a portion of the cellar (Feature 35) associated with this house was excavated because an agreement reached with the property owners removed this part of the site from potential destruction. A 10 by 15-foot section of

the cellar was exposed and a 5 by 12-foot trench was excavated down to the cellar floor. The bottom of the cellar was at 4.5 feet below the bottom of the plowzone. During excavation, the four corners of the house were also uncovered. The cellar was found under the eastern portion of the building but not the western section, indicating that the cellar did not extend the entire length of the building.
