THE EXCAVATION OF AN 18TH CENTURY DUTCH YELLOW BRICK FIREBOX AND CHIMNEY STACK IN ANNE ARUNDEL COUNTY, MARYLAND

Al Luckenbach

Abstract

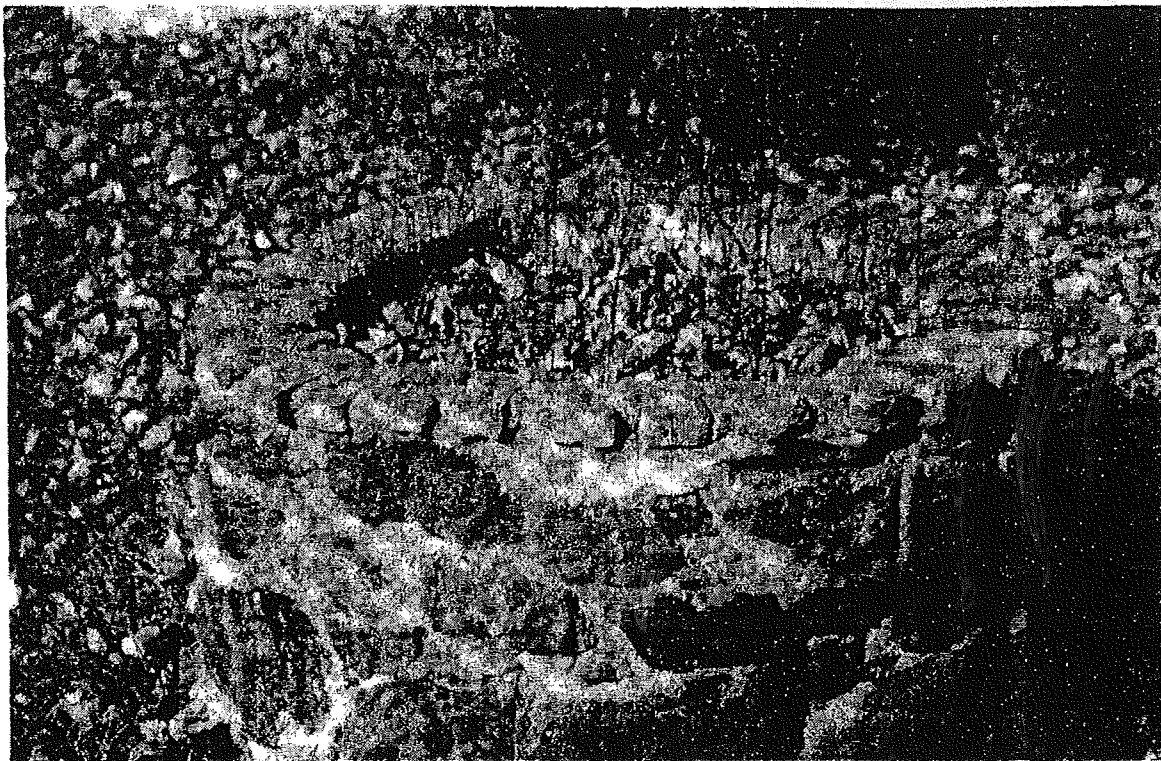
FIGURE 1. Dutch yellow klinkers utilized in the construction of a "wishing well" planter.

bricks had been removed from the site and were being used for a variety of purposes such as edging for flower borders and planters (see Figure 1).

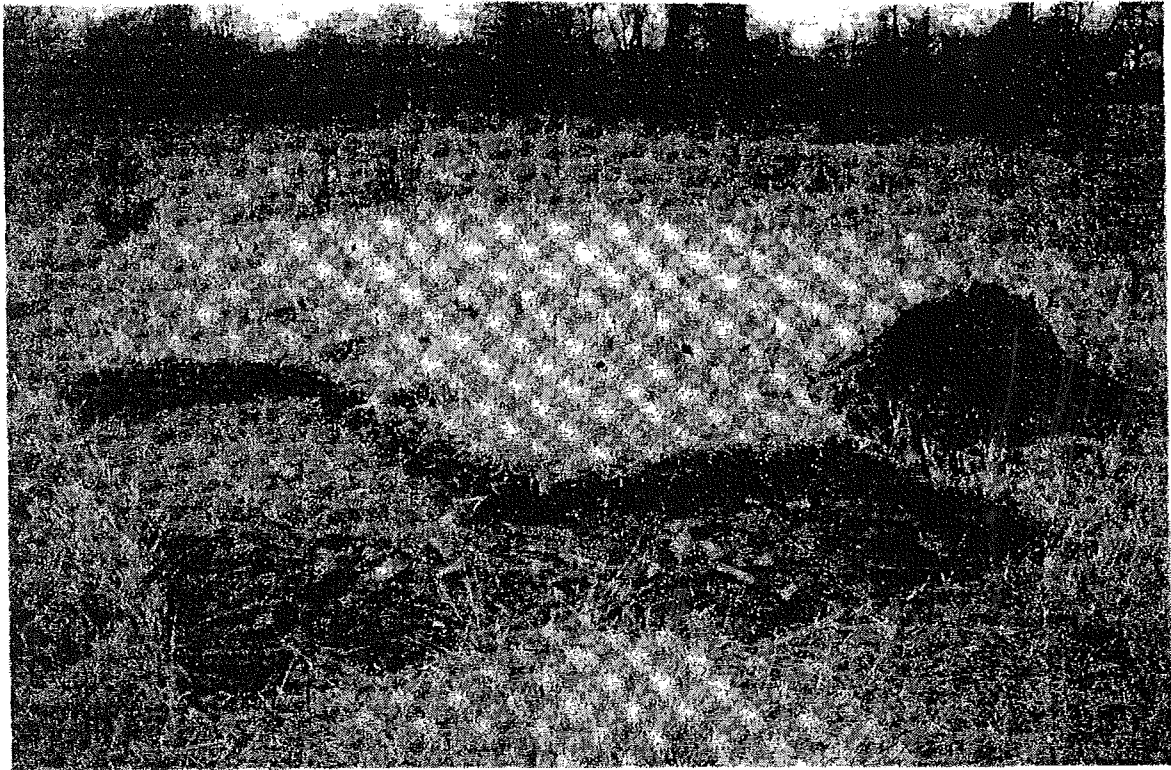
FIGURE 3. Early excavations showing site outlined in Wire Grass.

At this point in the investigation, an intriguing phenomenon was noted which was to be confirmed at the conclusion of the excavations. Once the dimensions of the site were determined, it could be seen that a specific and exclusive vegetative cover of Wire Grass (*Cynodon dactylon*) had grown to almost exactly outline the building location (see Figure 3). This tough grass, with an extensive root system, obviously was attracted to the extremely low pH derived from the extensive amounts of mortar and plaster introduced into the soil. The pH variability between the area of the chimney fall and the rest of the field would have been in particularly sharp contrast due to the high acidity noted previously for Evesboro soils.

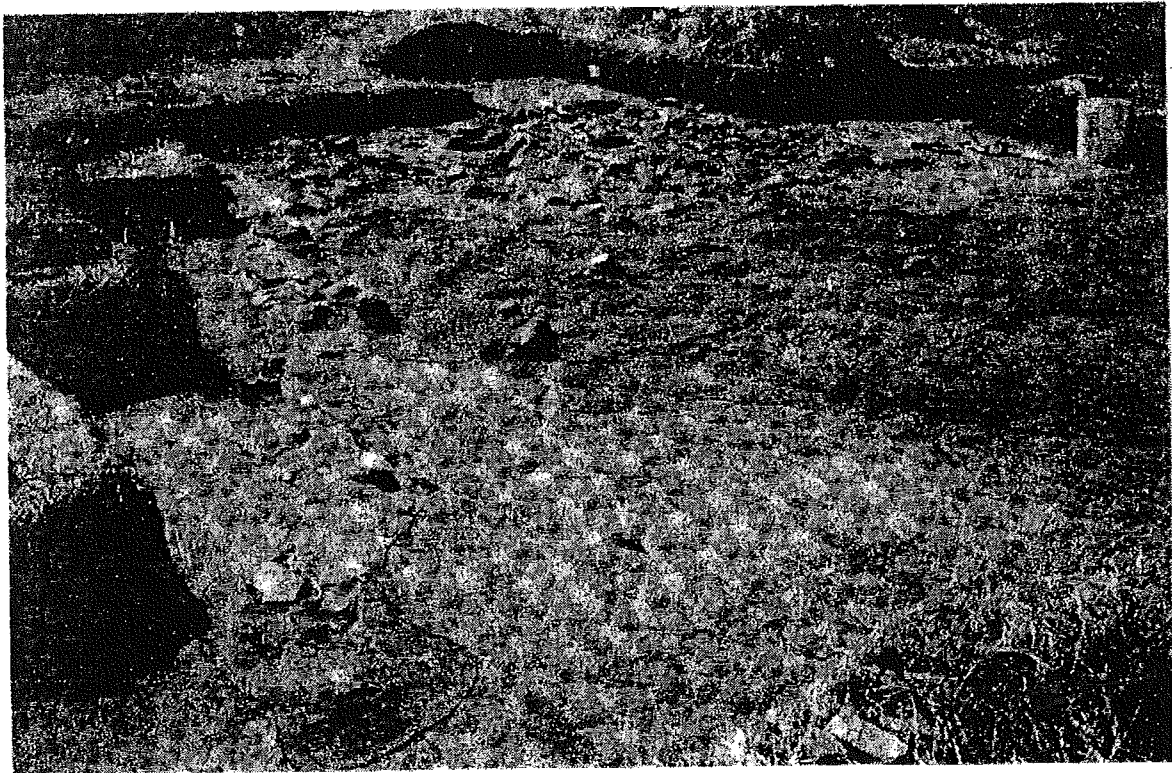
FIGURE 4. View of excavations showing foundation wall and firebox rubble (top center).

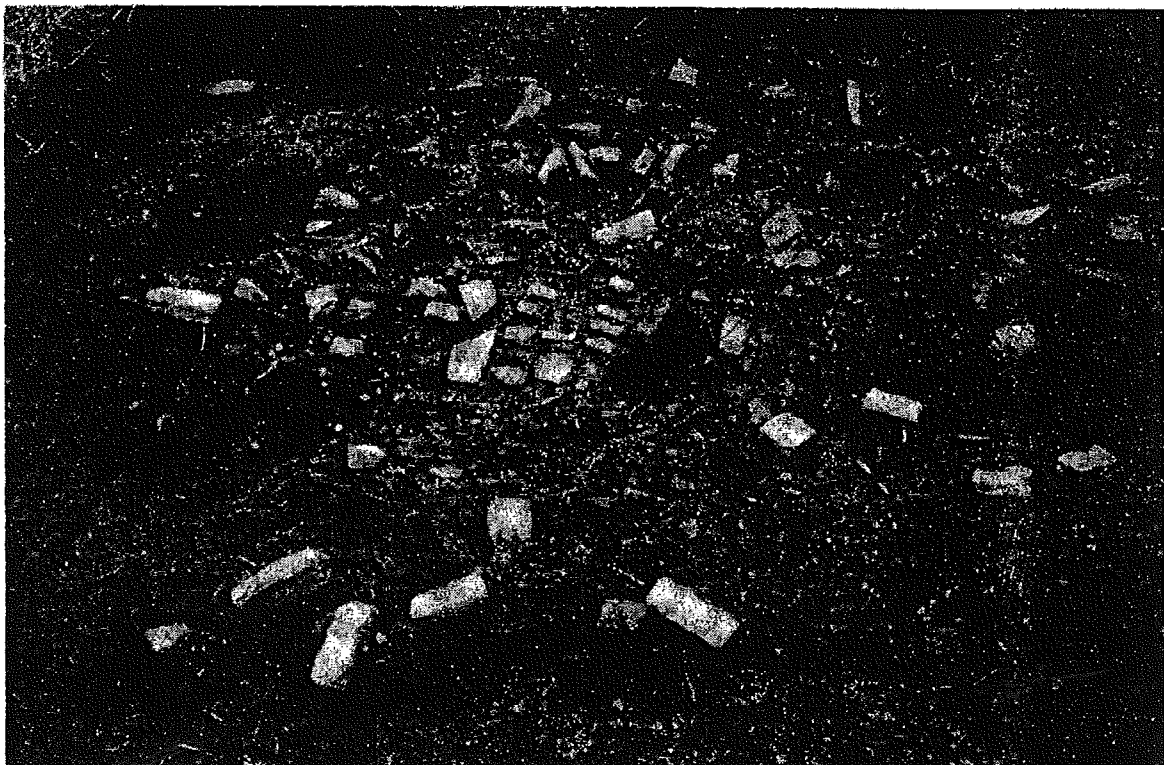
FIGURE 7. Firebox pattern as first revealed in excavations.

After the removal of a shallow and irregular plowzone, the remains of the chimney fall presented a generally disturbed and jumbled appearance with the exception of an enigmatic pattern of yellow klinkers which was presumed to be related to the firebox (see Figure 7). It was not until the bricks in this area were being disassembled and removed that the construction technique utilized for the firebox was revealed.

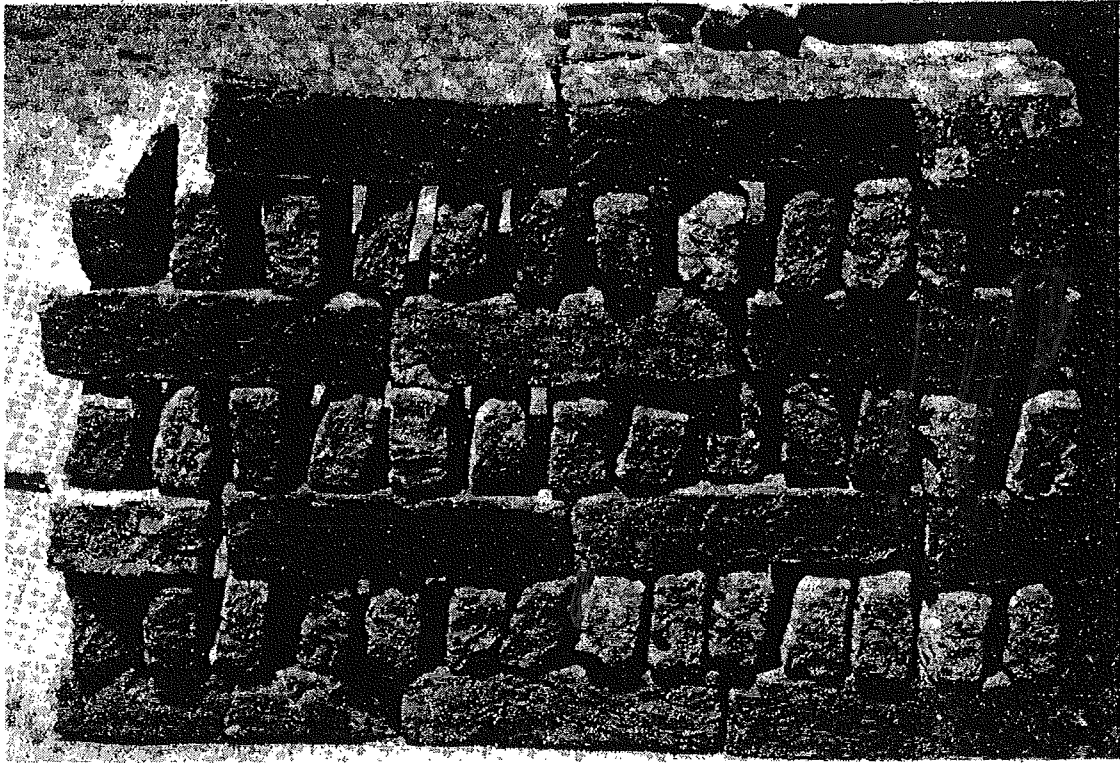
FIGURE 8. Reconstruction of the exterior of the firebox (lacking mortar and scribing).

Courses of large red brick stretchers were found to be alternating with courses of yellow bricks, laid on their edges in a row-lock course (see Figure 8). A sandy, white oyster shell mortar was generously applied to create a joint averaging nearly an inch in thickness. These joints were carefully scribed, confirming the external, visible side of the construction (Figure 9).

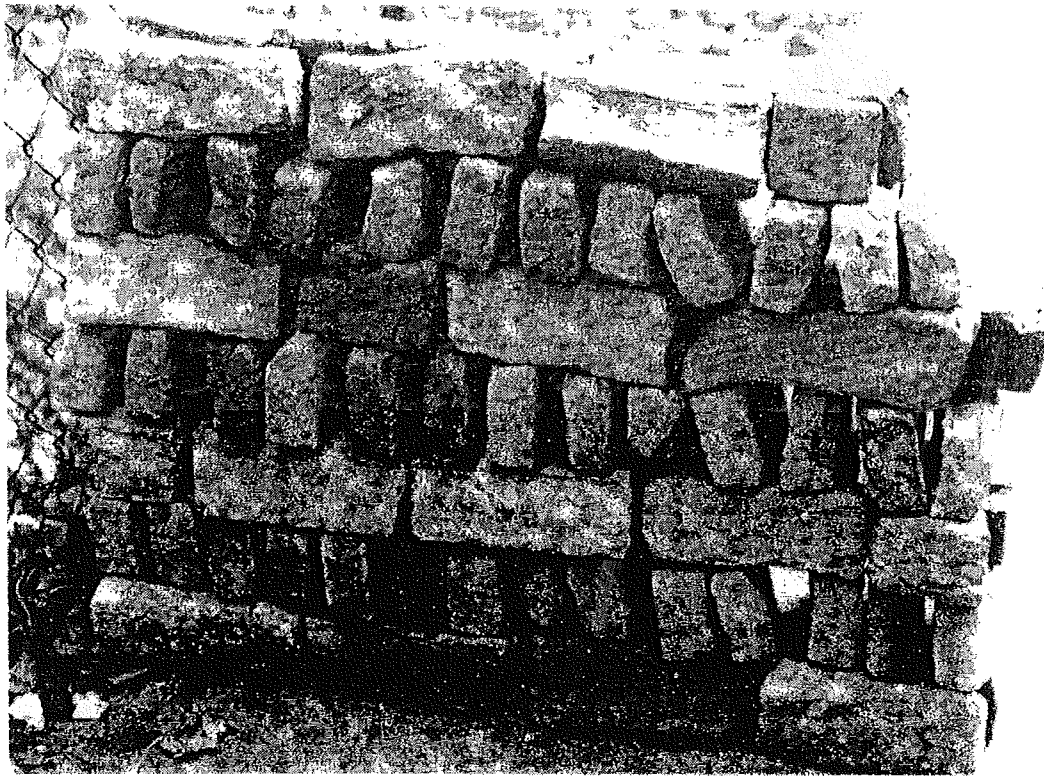
FIGURE 10. Reconstruction of the interior of the firebox (lacking mortar and parging).

Laying 6-inch yellow bricks lengthwise across the 3.5-inch width of the red bricks meant that approximately 2.5 inches of the yellow row-lock course would have projected into the interior side of the firebox in almost a shelf-like fashion. A flat interior surface was then created by mortaring yellow bricks on their stretcher edges into the spaces provided by these

"shelves" (see Figure 10). In this fashion the entire interior of the firebox was faced with hard yellow bricks which acted as firebricks. The interior was then parged, the sooty remnants of which can be partially seen in Figure 11.

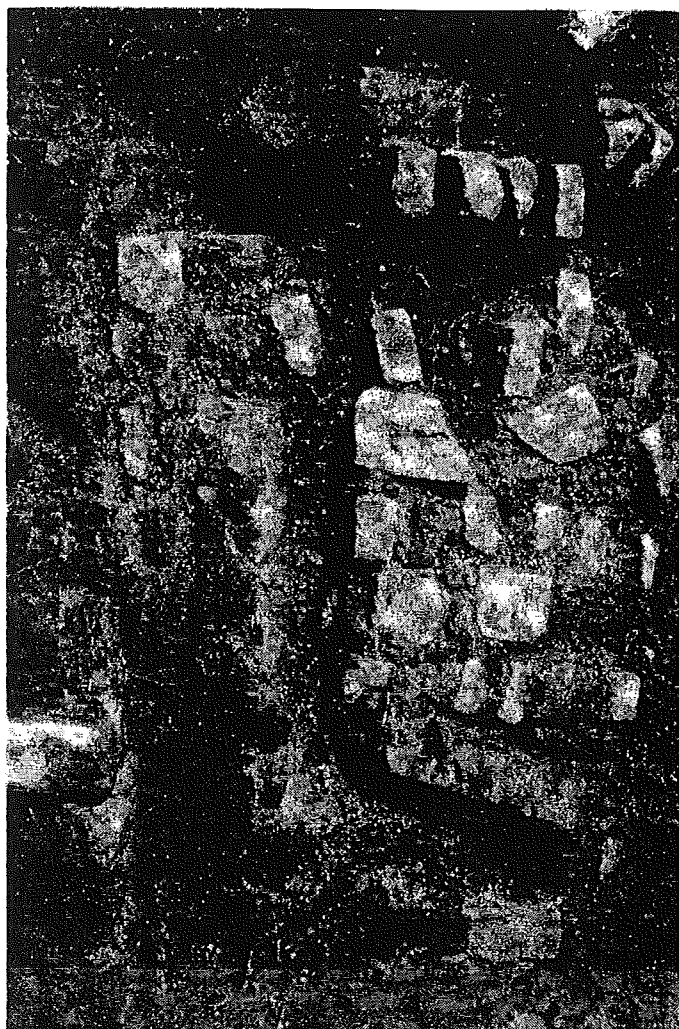
FIGURE 11. Articulated firebox interior during excavation.

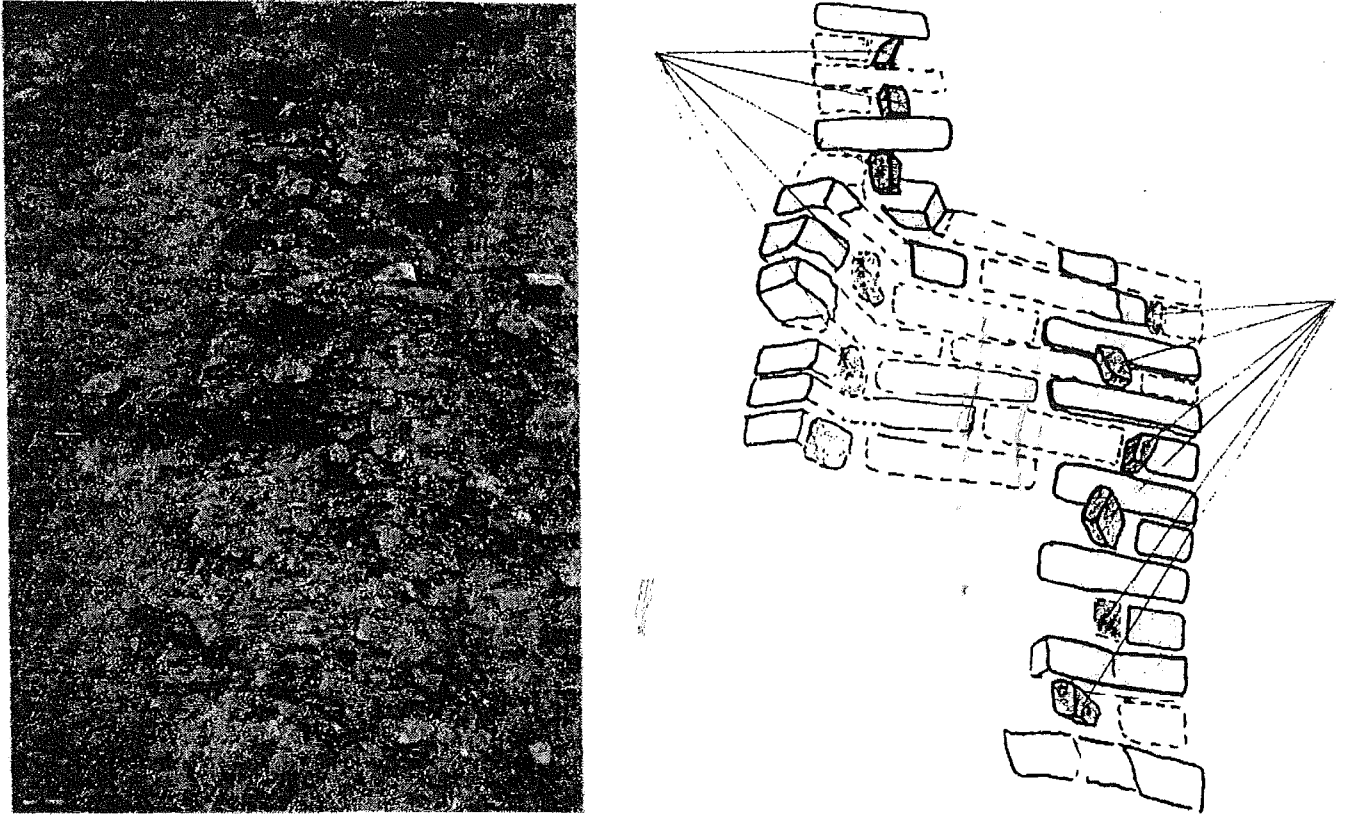
FIGURE 12. Articulated chimney stack as excavated, and diagram highlighting position of Dutch closers.

As the disassembly of the brick rubble continued outward from the firebox, other articulated bricks began to be revealed. As this masonry was uncovered it proved to be a partially intact side of the fallen chimney stack (Figure 12).

Approximately seven feet comprising parts of 26 courses had remained articulated after falling towards the interior of the structure. Given that this occurred, it is surmised that the chimney had outlived the wooden section of the building, since the interior framing did not appear to disrupt its fall. Interestingly,

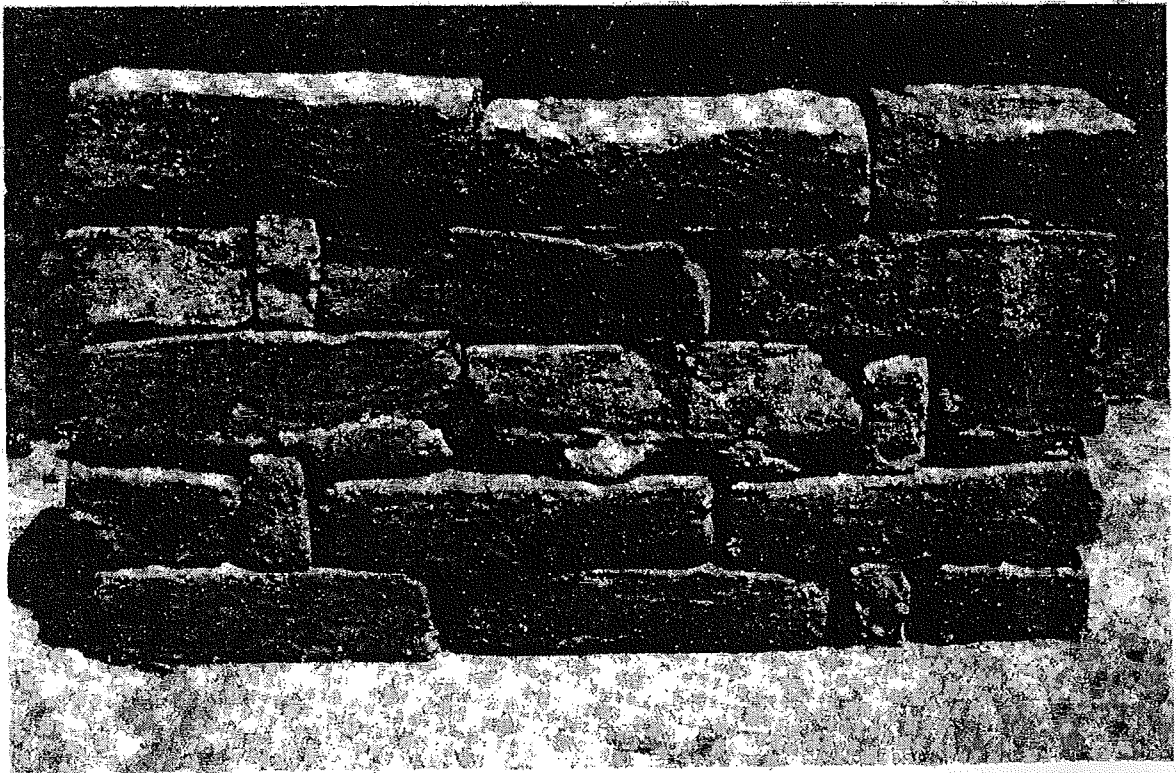
FIGURE 13. Reconstructed chimney stack, showing position of Dutch closers (lacking mortar).

The construction of the stack is depicted in Figure 13. Each course was made by first laying two red brick stretchers, then a half yellow brick on edge as a "queen closer," followed by a red brick header which formed the turn to the next side of the stack. This sequence was then reversed for the following course. The end result was a square stack with external dimension of about 24 inches square, and internal dimensions of 17 inches square. The visual effect of this bonding pattern was that one small yellow brick closer appeared on alternating sides of the stack at each course (see Figure 13).

This bonding pattern continued for approximately half of the stack section which had remained articulated after hitting the ground. Then, about three feet from the apparent top of the chimney, a fragment of a broken red brick appeared as a substitute for a yellow closer. On the following course, no closer was present at all, but the gap was spanned by a 2-inch thick section of mortar. The same was true on the re-

maining courses except that the amount of mortar was reduced to the standard 1-inch thickness. The net effect of abandoning the use of a yellow closer was to reduce the size of the chimney stack's aperture to about 15 inches square (22 inches externally).

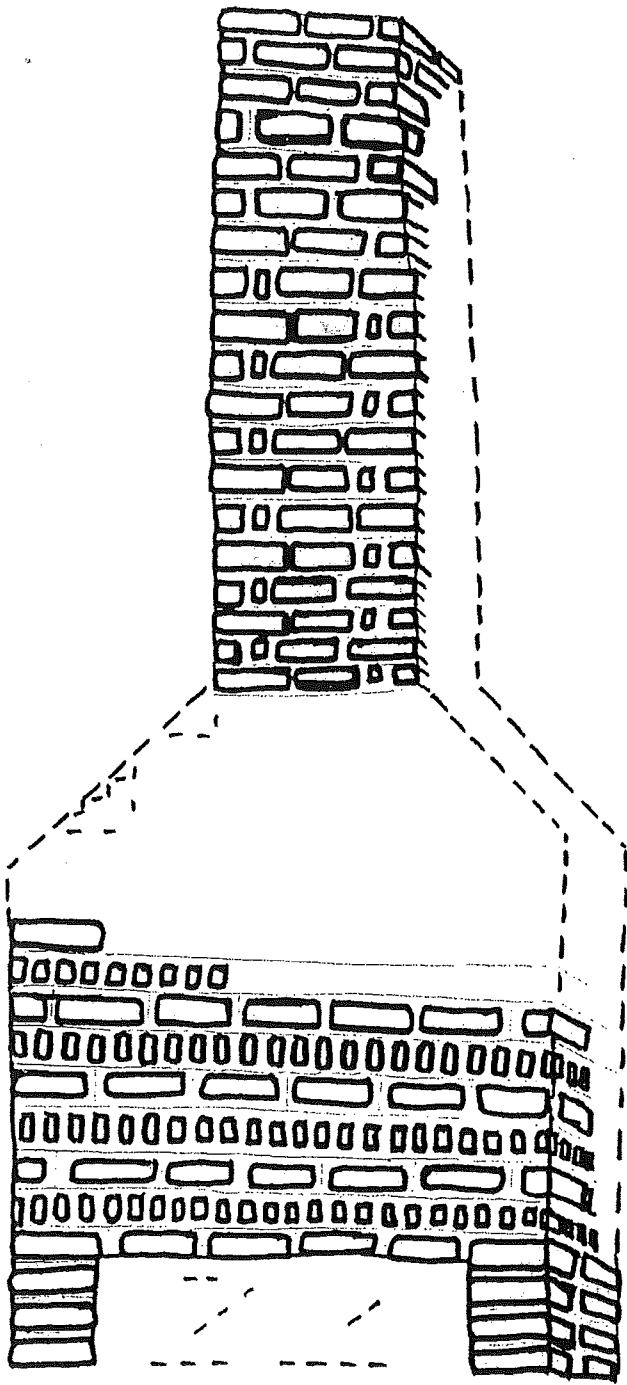
FIGURE 14. Hypothetical chimney reconstruction (note piers).

and four more were found to be turning the corner of the chimney. These eight bricks produced an L-shaped pier-like effect (see Figure 14). Clearly this construction by itself would have been insufficient to provide support for the chimney.

Since the base of a masonry chimney must be fairly massive, we are left with speculation as to what its nature might have been. At this point the only theory which can be advanced would involve some kind of ground-laid timber beams sitting between the L-shaped brick "piers," the interior of which may have been filled with earth or sand. Perhaps the gable-end sill for the main structure was somehow incorporated into this conjectural support system. Since no known analogies exist for this type of chimney support, it must remain in the realm of pure speculation.
